2 15
LIBBY DAM AND LAKE KOOCANUSA PROJECT, MONTANA

LEFT BANK SLOPE

REPORT DOCUMENTATION PAGE		READ INSTRUCTIONS BEFORE COMPLETING FORM
1. REPORT NUMBER	2. GOVT ACCESSION NO. AD A142 021	3. RECIPIENT'S CATALOG NUMBER
4. TITLE (and Subtitle) Libby Dam and Lake Koocanusa Project, Montana Left Bank Slope		5. TYPE OF REPORT & PERIOD COVERED Final

20. ABSTRACT (Continue on reverse side if necessary and identify by block number) Report details the geology and history of the Libby Left Bank Slope instrumentation program, presents plots of instrumental data for the period 1967-1983 and provides a technical evaluation of the present status of the slope.

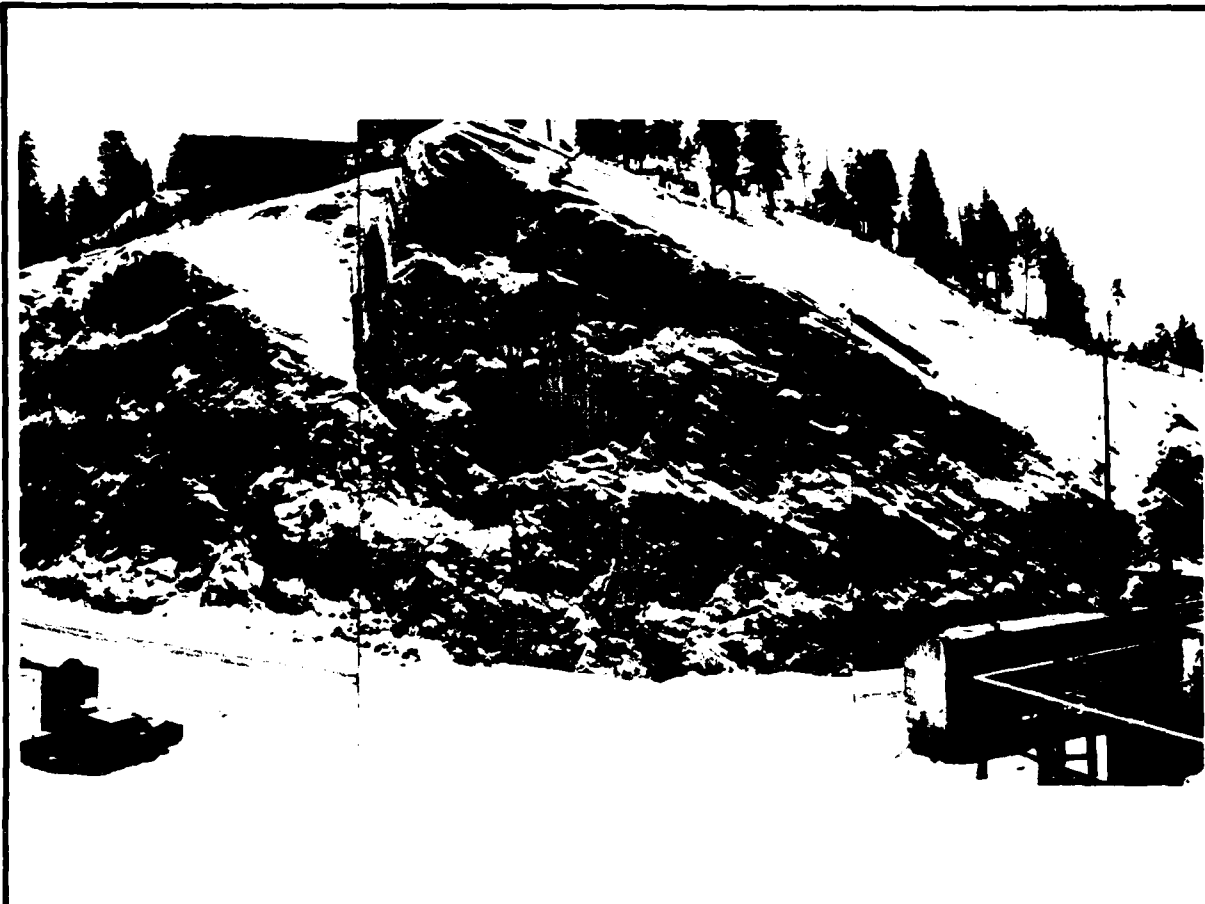
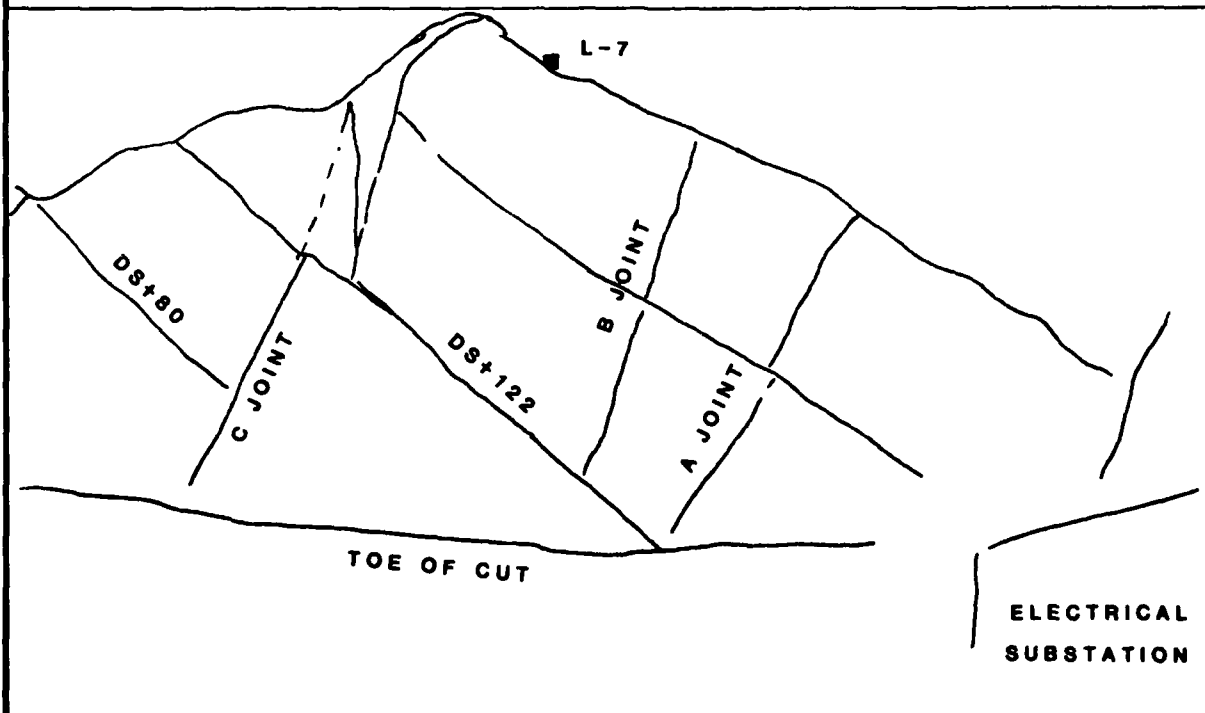
FIGURE 3.1

COMPOSITE PHOTOGRAPH OF MSH 37 CUT
ADJACENT TO LEFT ABUTMENT, WINTER 1968.

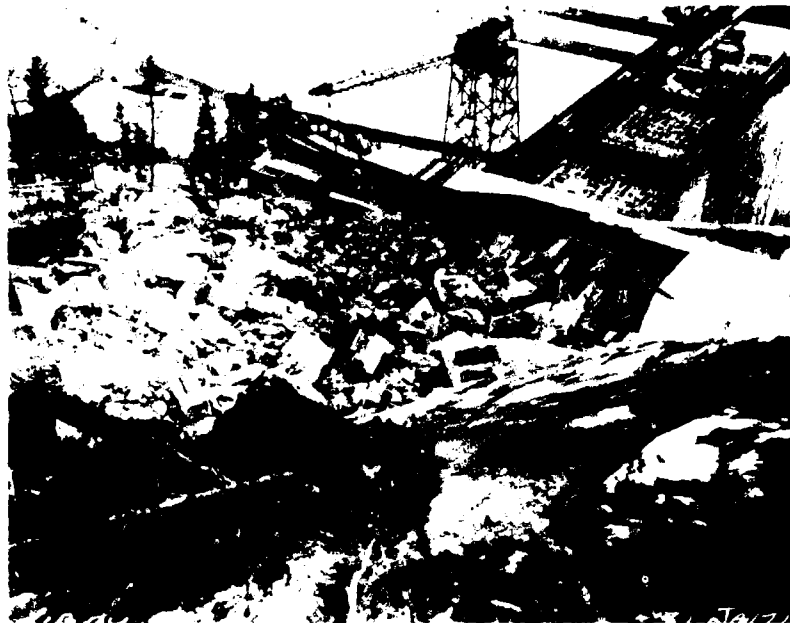
3.11a View down slide along surface of the Dirty Shame +122 Bedding Fault to rubble pile. Refrigeration plant on right, aggregate cooling facility right center, uncompleted dam upper right.

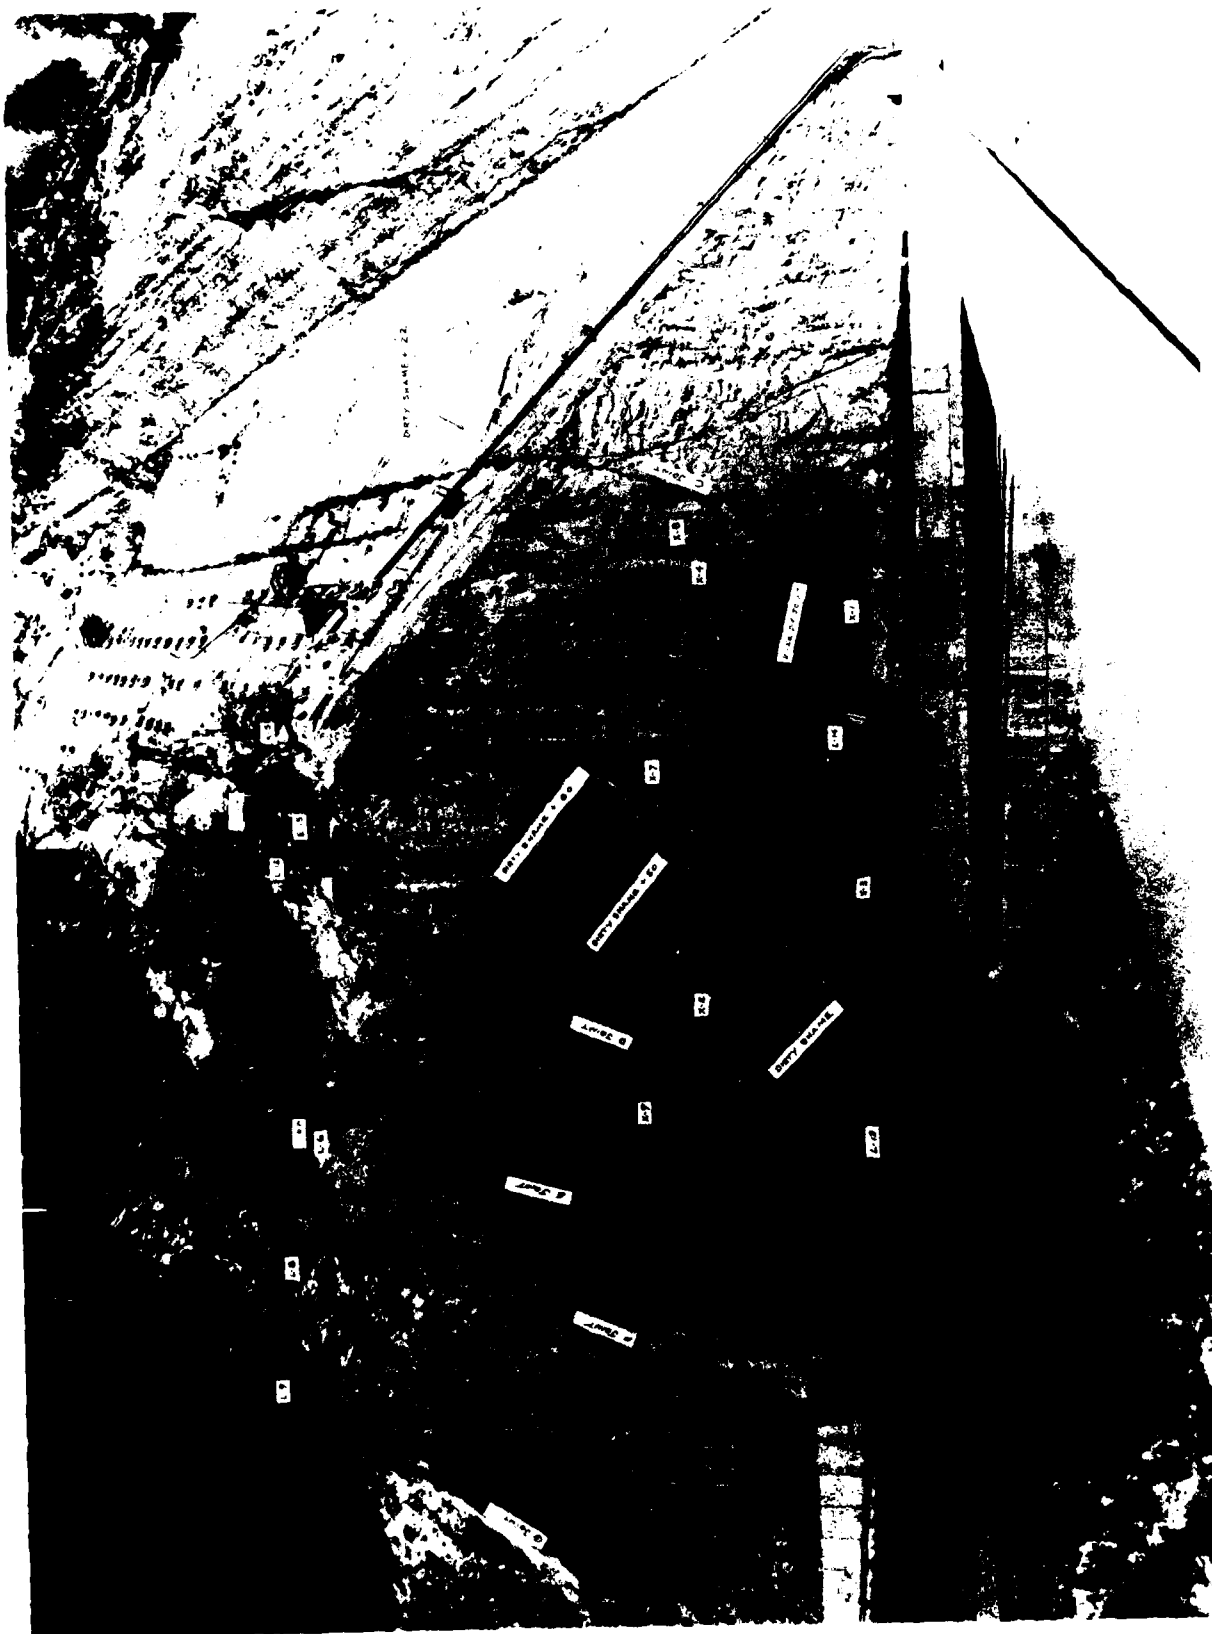
FIGURE 4.2

Left Abutment Rib & MSH Cut Face

(5) D Joint (Figure 4.8, Plates 7, 8, and 9). Early data prior to the transducer change late in 1973 suggest some adjustment across the D and D Splay system (extension on the D and compression on the D-Splay) (Refer to L-9, appendix B). Subsequently, adjustments have continued to occur notably during the 1978-1980 period and again in 1982 (L-9 (2-3)). The face extensometer (X-2) showed an annual cyclic variation on the order of 0.03 inch for several years (see vernier plot) and has shown continuing but decelerating borehole compression which by the end of 1983 approaches nearly 0.25 inch. This suggests that the rock wedge upstream from the D Joint is in downslope motion since late 1979 or early 1980. The data suggests continued, periodic adjustment along the D Joint and perhaps loosening of a highly jointed face block (figure 4.2).

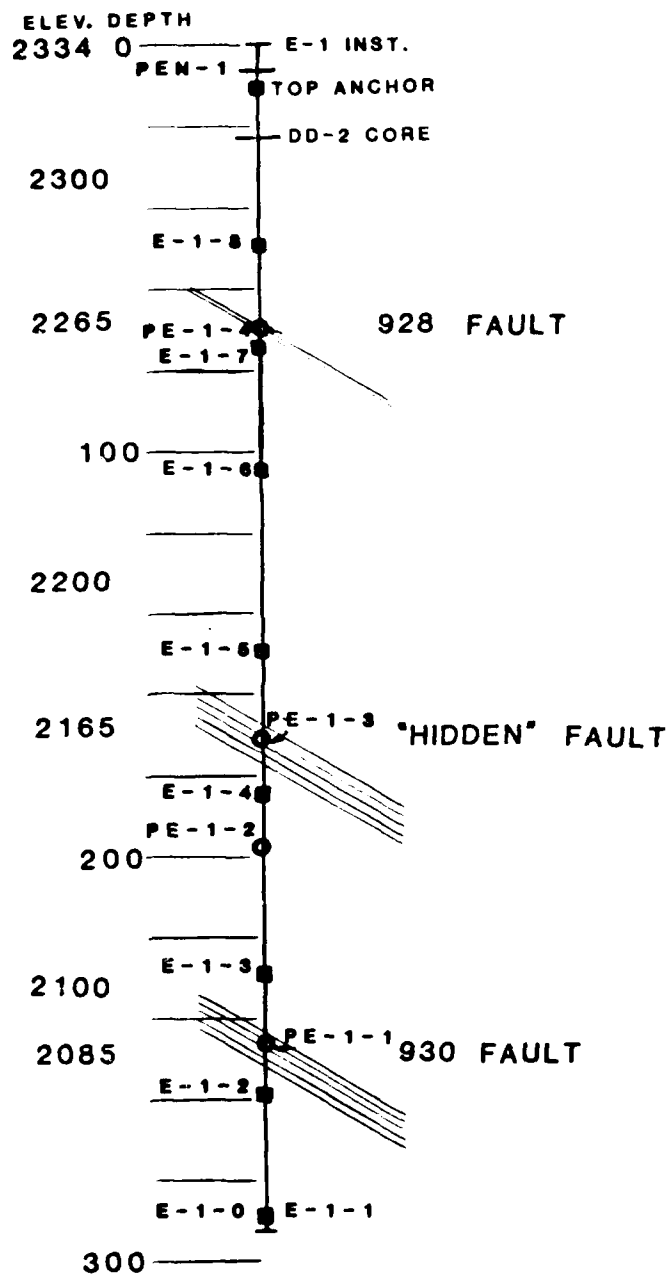
NOTE: ALL PEN-1 SENSORS INOPERATIVE SINCE 1972.

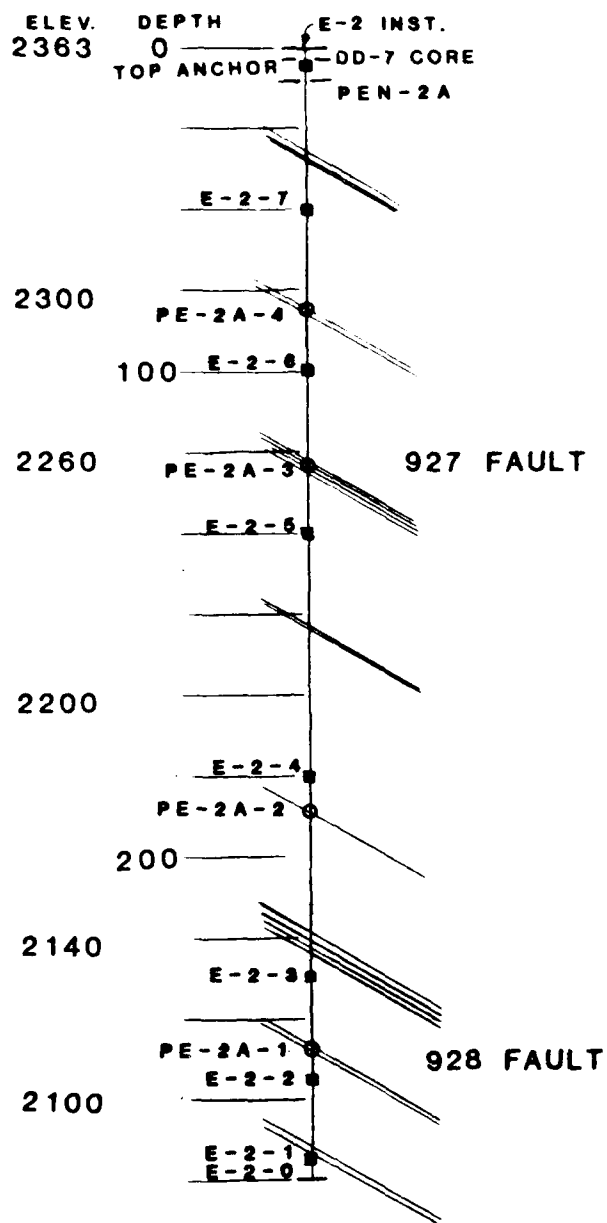
NOTE: ALL PEN-2A SENSORS INOPERATIVE SINCE 1972.

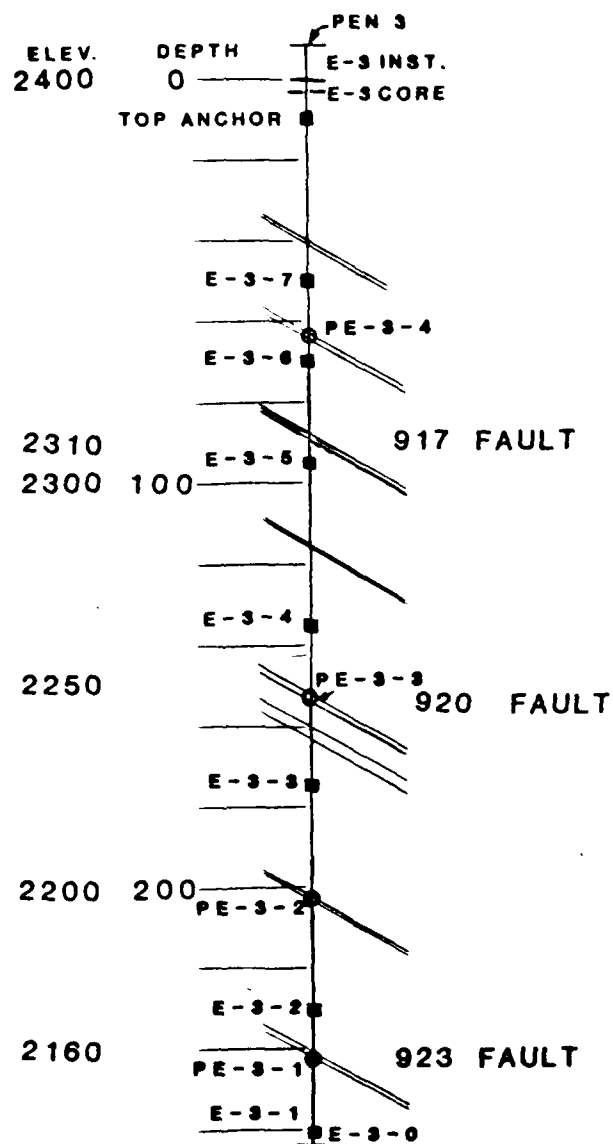
NOTE: PE-3-2 AND PE-3-4 INOPERATIVE SINCE 1972.
PE-3-3 INOPERATIVE 1974.
PE-3-1 INOPERATIVE SINCE 1976.

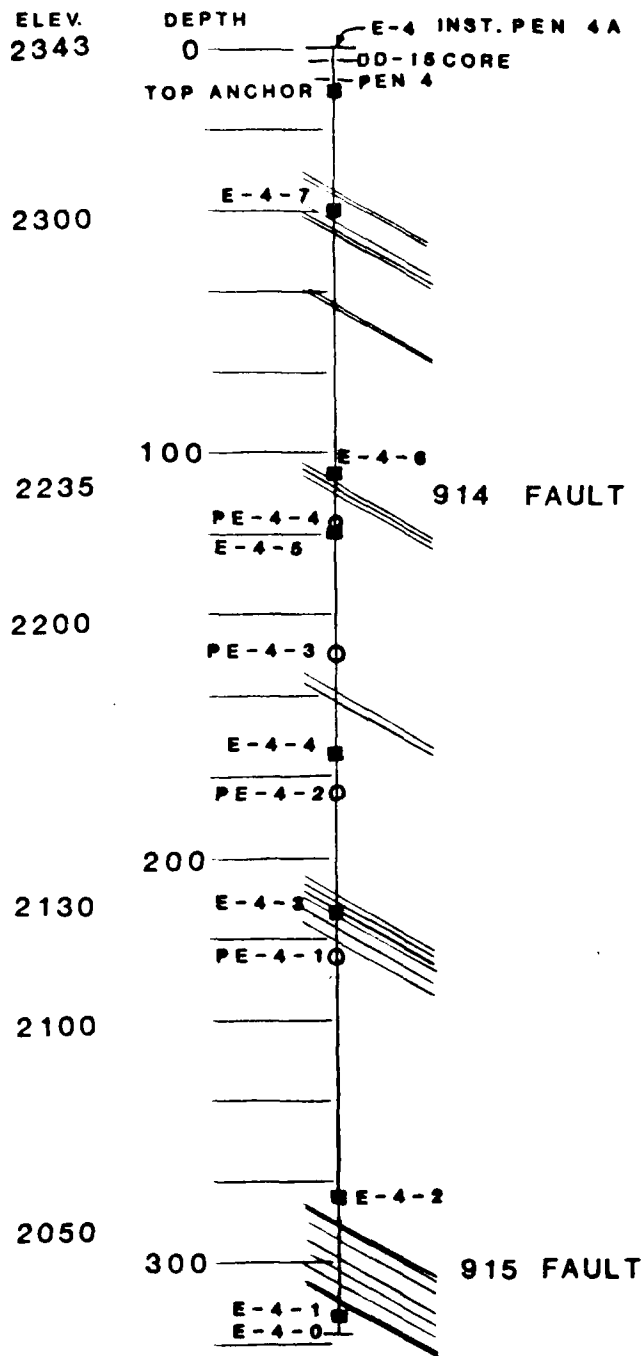
NOTE: ALL PEN-4 SENSORS INOPERATIVE SINCE 1972.

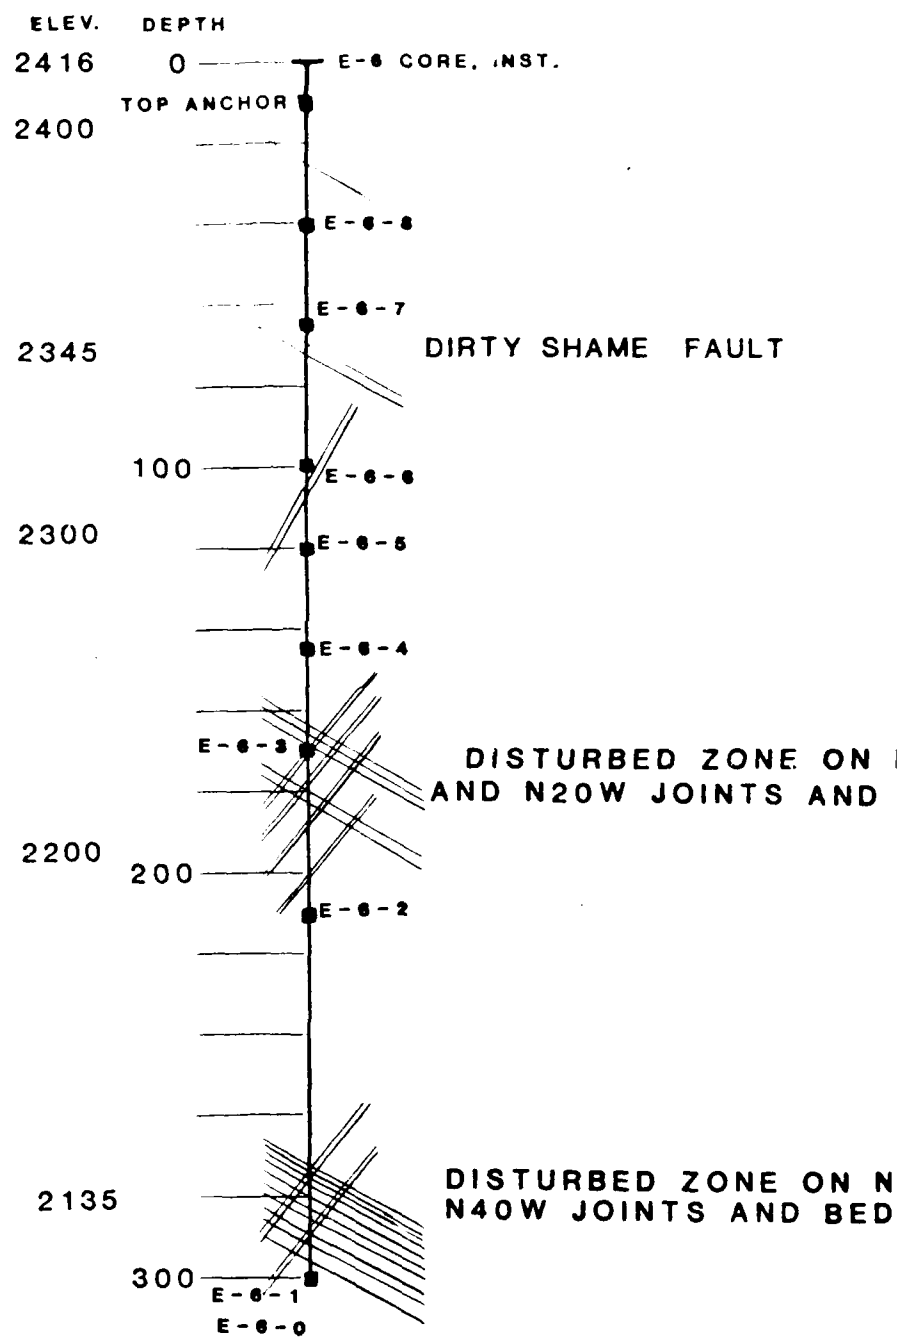
E-8

DISTURBED ZONES SHOWN MOSTLY INVOLVE UNDESIGNATED BEDDING FAULT ZONES BELOW THE 930 BEDDING FAULT. NUMEROUS HIGH ANGLE, E-W FRACTURES THROUGHOUT BADLY FRACTURED.

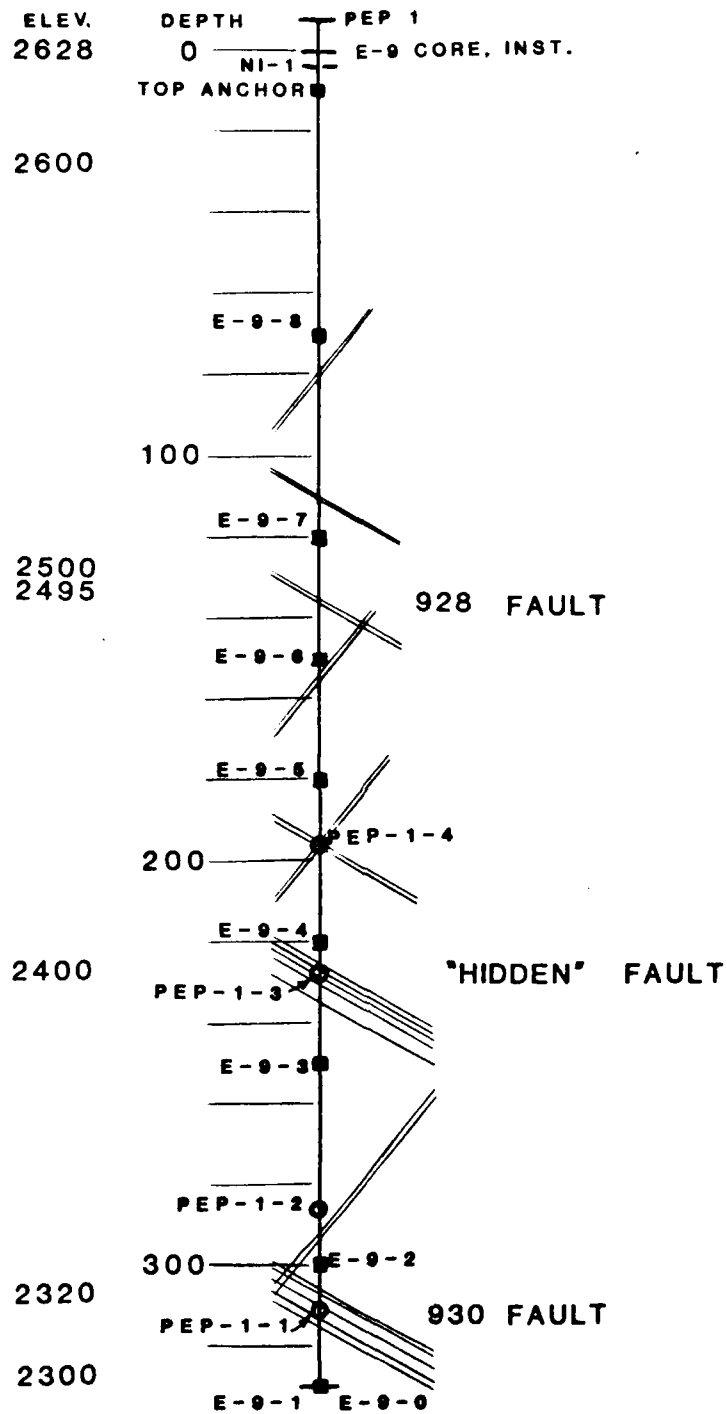
NOTE: PEP-1 SENSORS 1 AND 2 INOPERATIVE.

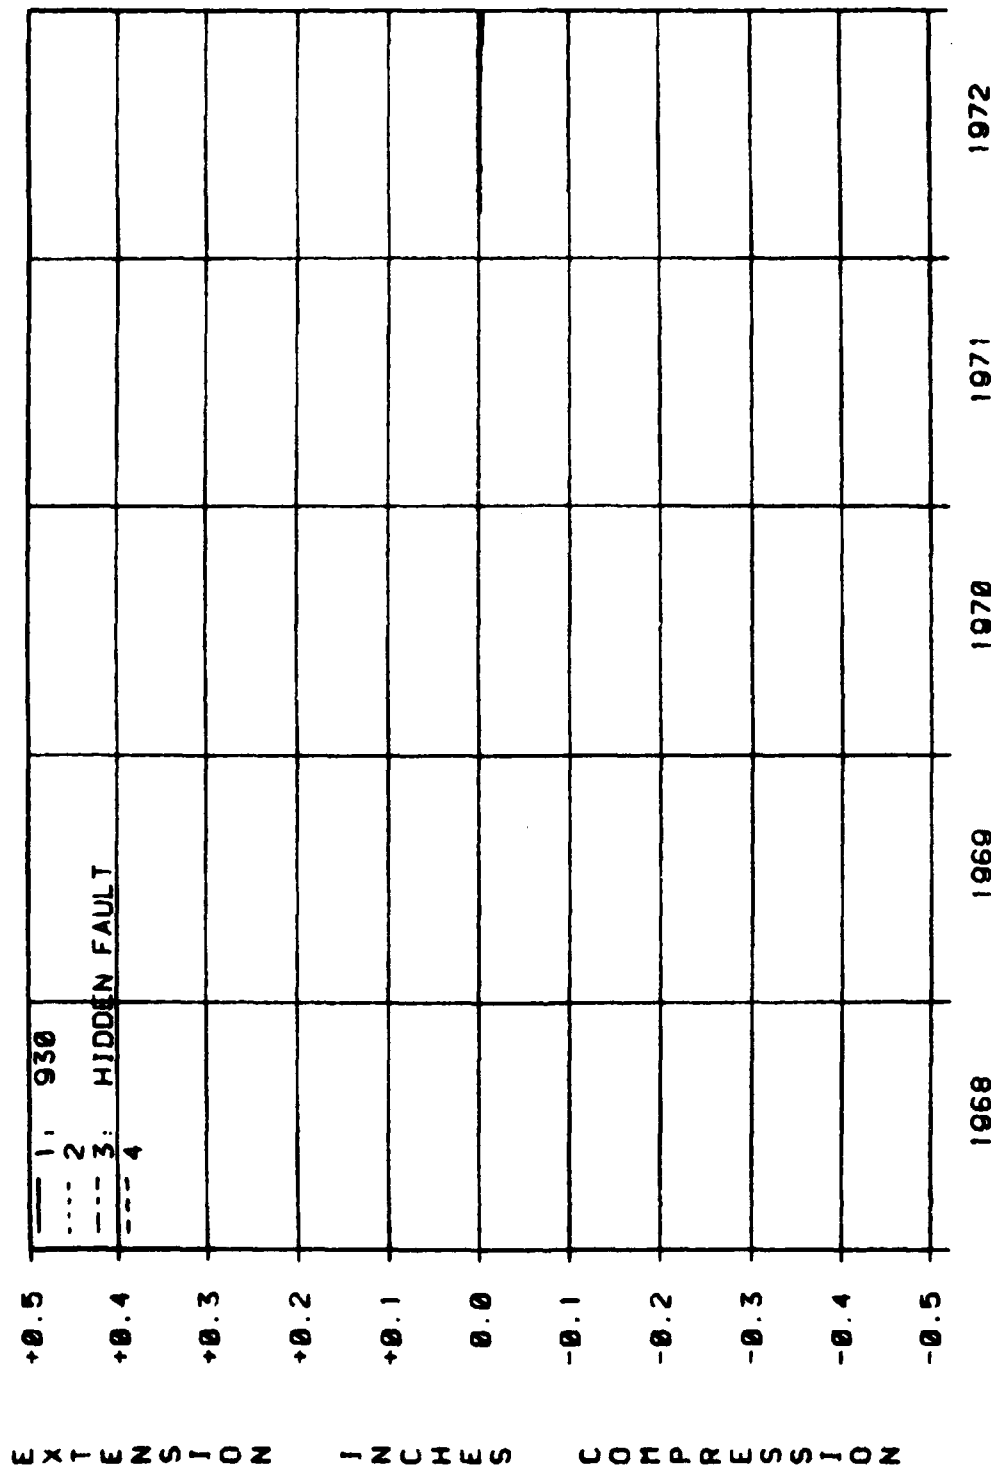
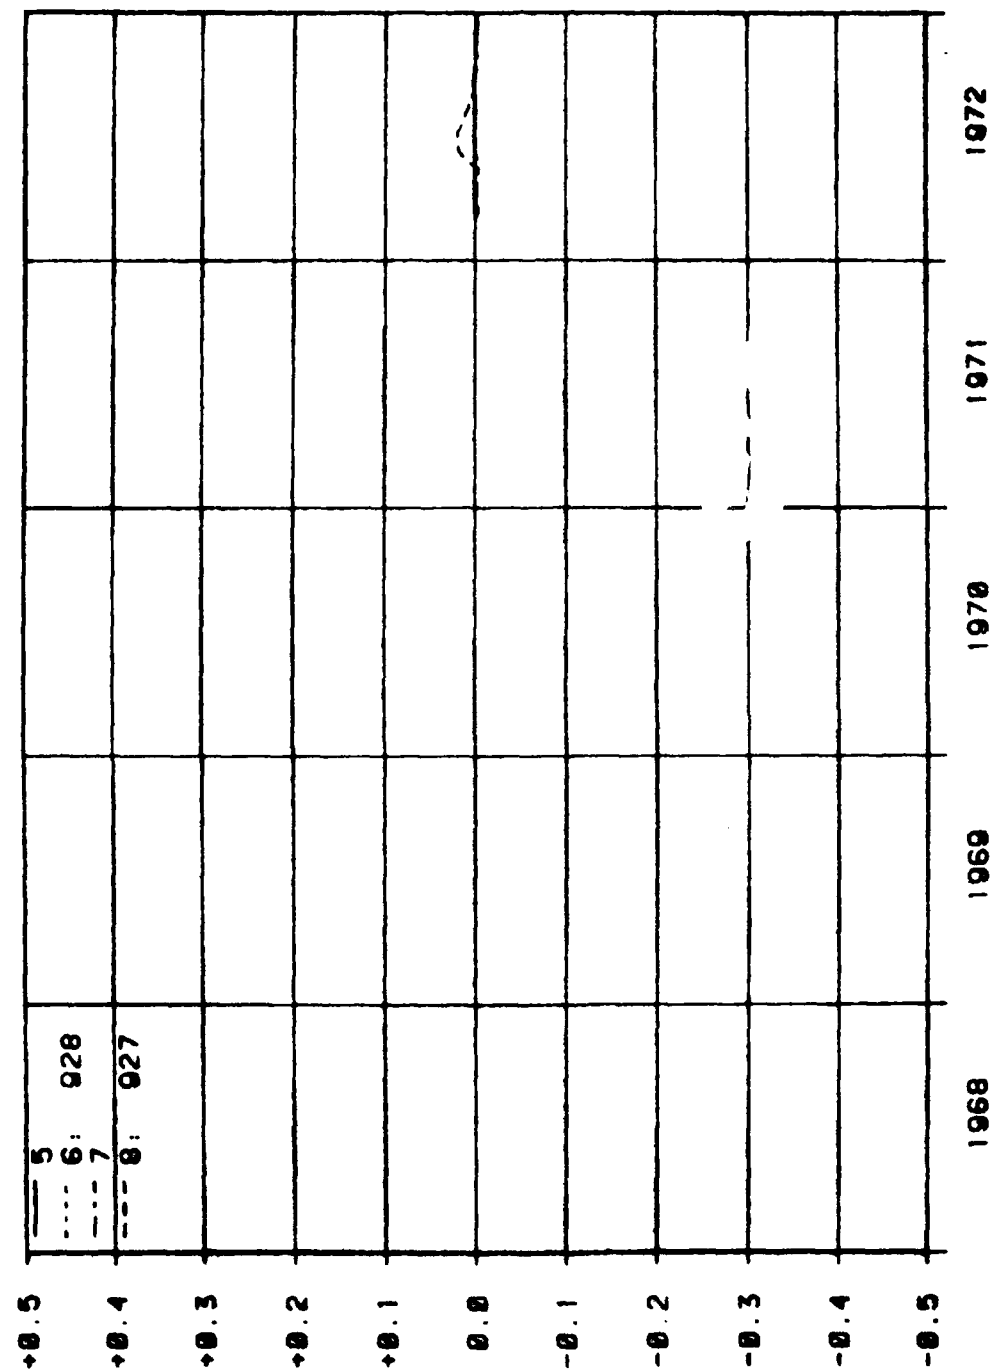
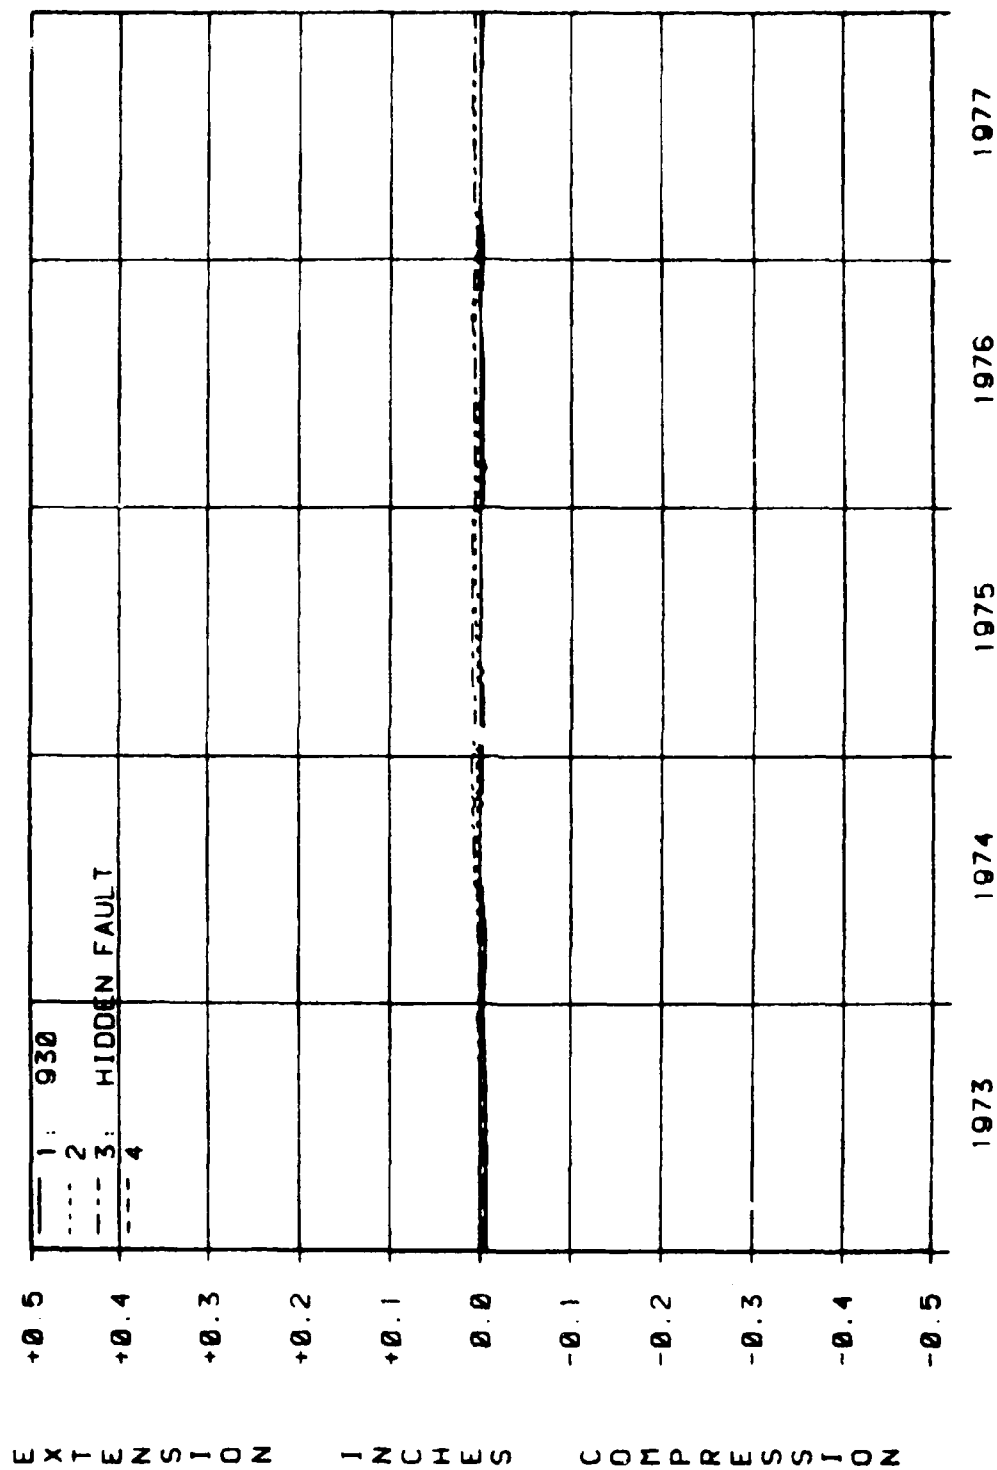
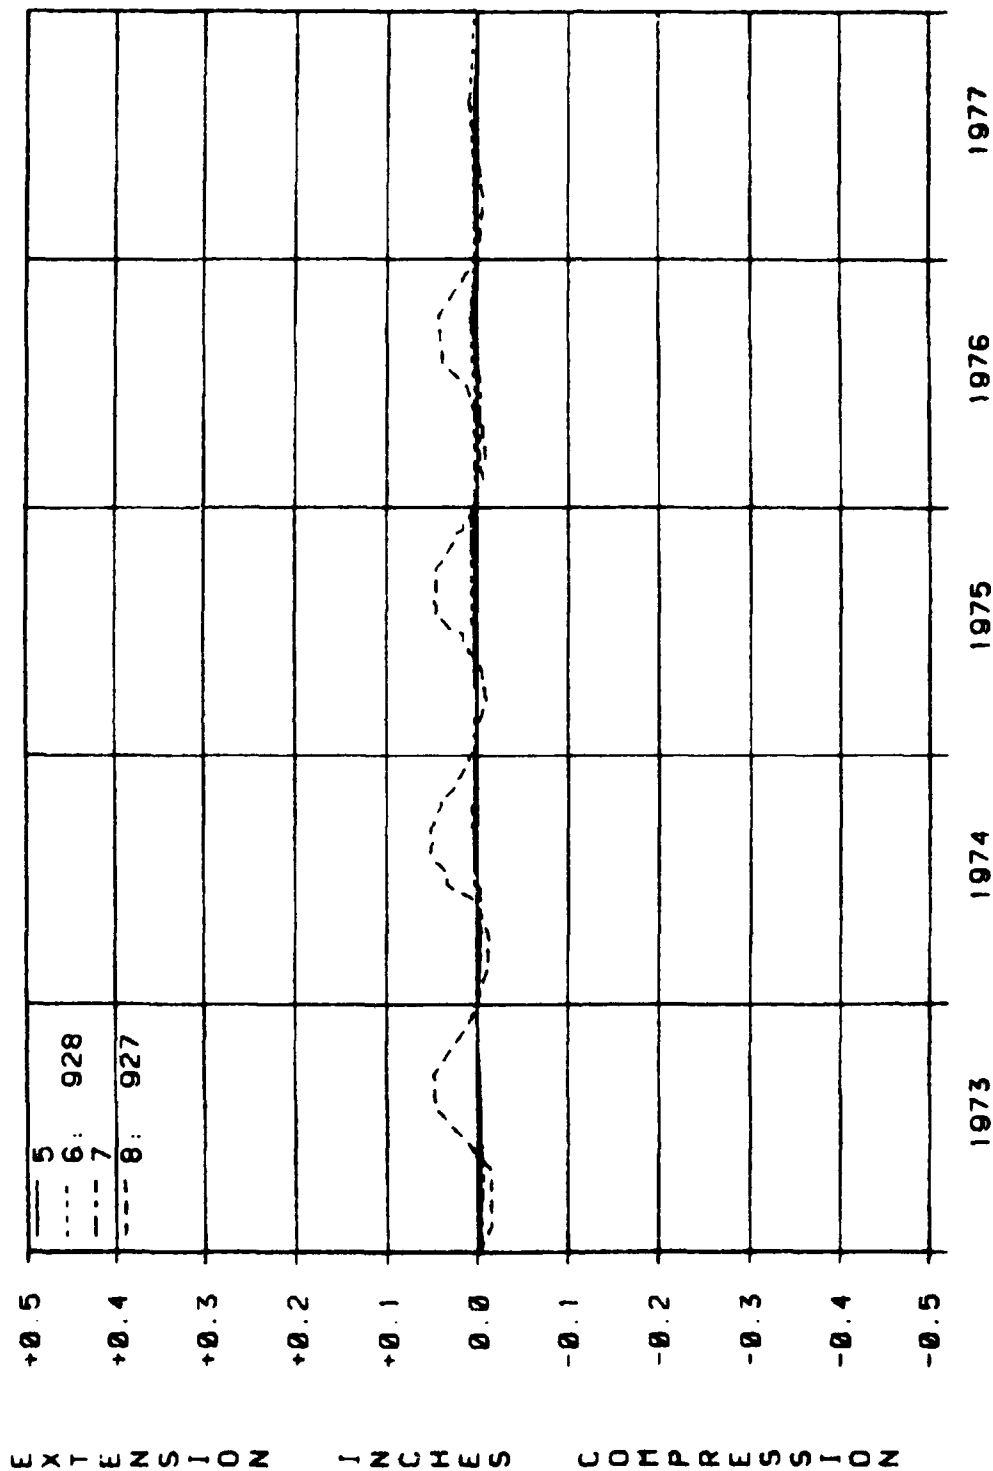
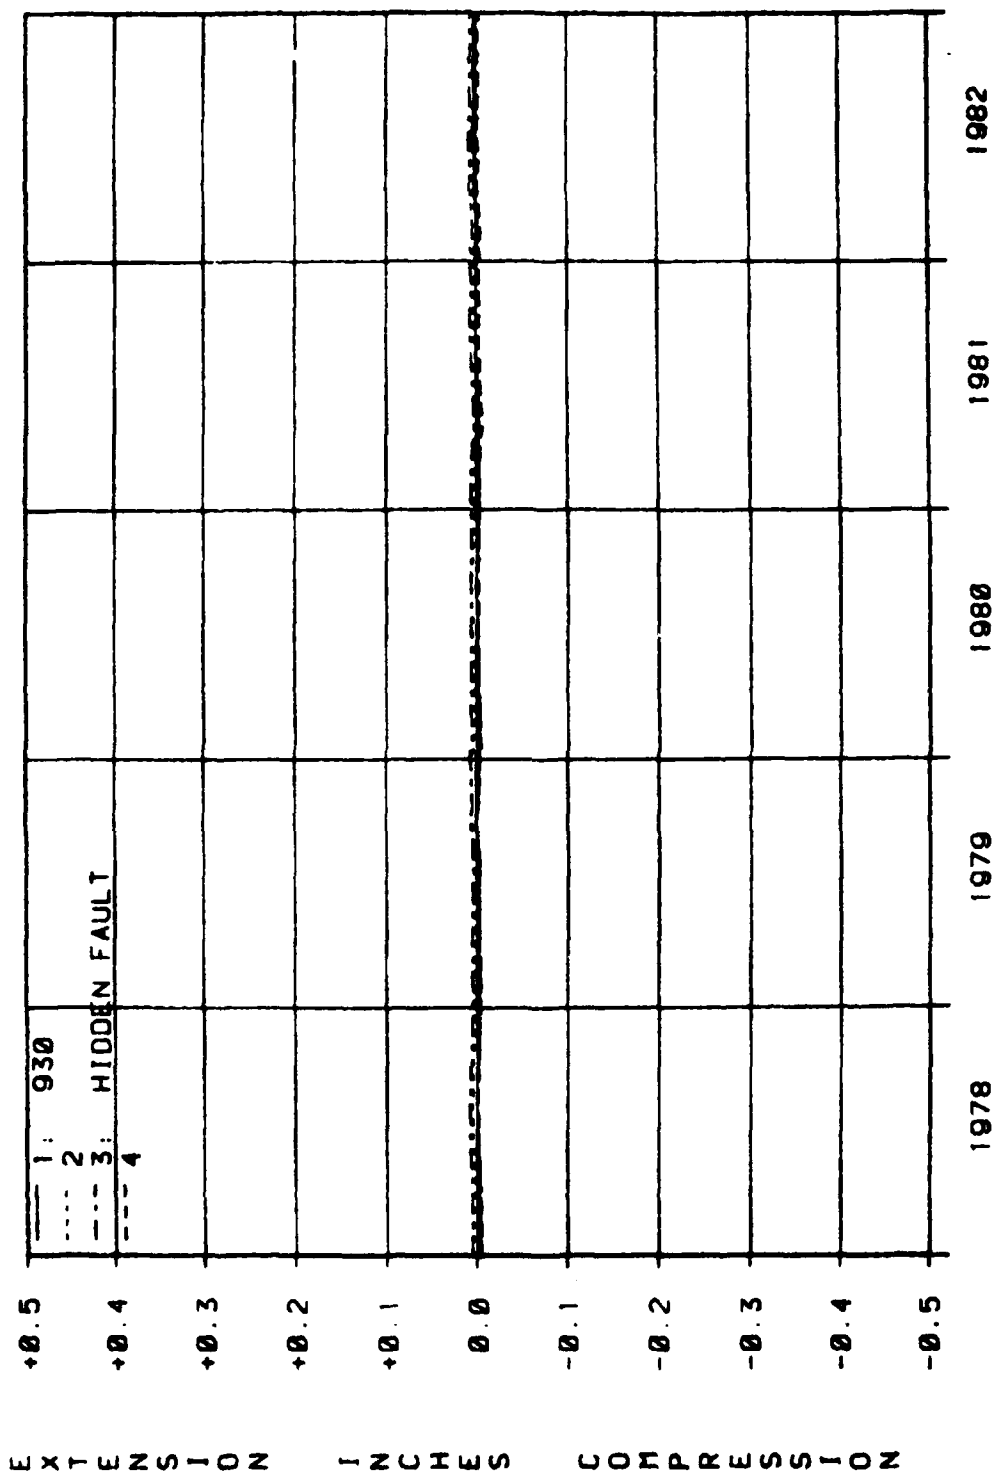
LIBBY LEFT BANK E-10 (DELTA DISPLACEMENT)

c. Extensometer Analysis. On the 928 Bedding Fault, the shallowest of the three major faults in the rib, the small amount of borehole compression (E-1-7) in mid-1972 may be either downslope movement or actual consolidation due to construction activity (figure 4.15a). No further activity is noted. The Hidden Bedding Fault showed a minimal compression at the toe, accumulating mostly in 1973 (figure 4.18b), but has been stable since. The 930 Bedding Fault exhibited stability until late in 1981. The two lower sensors of E-1 (E-1-1 and E-1-2, see appendix C), the latter of which crosses the Hidden Bedding Fault, showed extension on the order of 0.08 to 0.18 inch at this time, while the totalizer (E-1-0) showed compression on the order of 0.05 inch. The opposing reaction appears to be an instrumental problem, casting some question on viability of further data from the instrument. Early in 1981, E-1-8 showed compression on the order of 0.04 inch, indicative of downslope movement of a surficial block. This movement was not directly substantiated by the totalizer which may no longer be a viable sensor. The most well documented motion in this rib was during the period 1973 to 1976, beginning with the second pool rise, when the near surface sensor at the toe of the rib, E-1-8, indicated compression on the order of 0.3 inch, suggesting a downslope slip on a shallow, unnamed bedding fault of about 0.6 inch (appendix C, E-1 plots). No further evidence of slippage was noted after the 1976 pool rise. Seasonal cyclic motion in response to ambient temperature changes in the surficial rock mass high on the slope is seen on both E-10 and E-11.
